**CENTER POINT-URBANA COMMUNITY SCHOOL DISTRICT
FACILITIES MASTER PLAN
2022**

CENTER POINT-URBANA CSD MASTER PLAN

EXECUTIVE SUMMARY

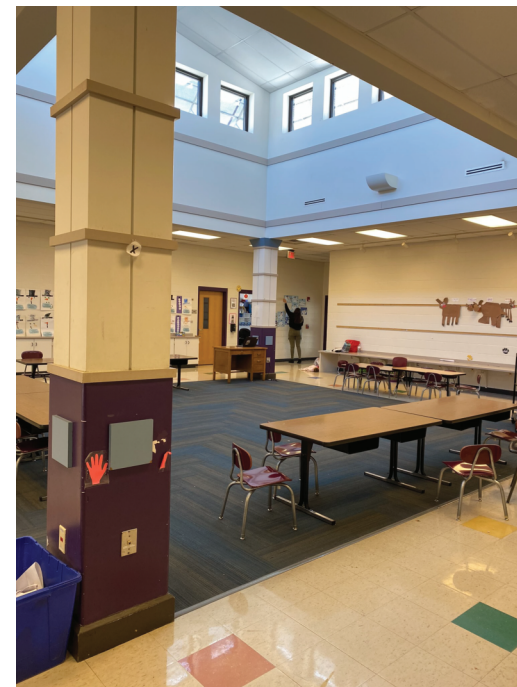
Typical learning pod condition

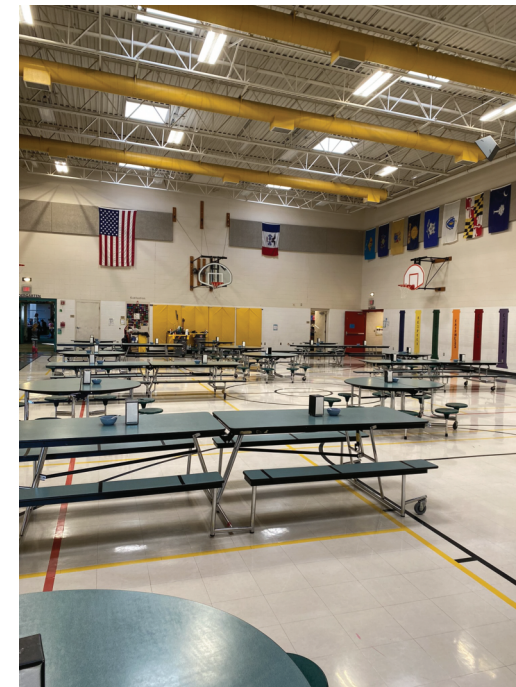
Multipurpose room condition

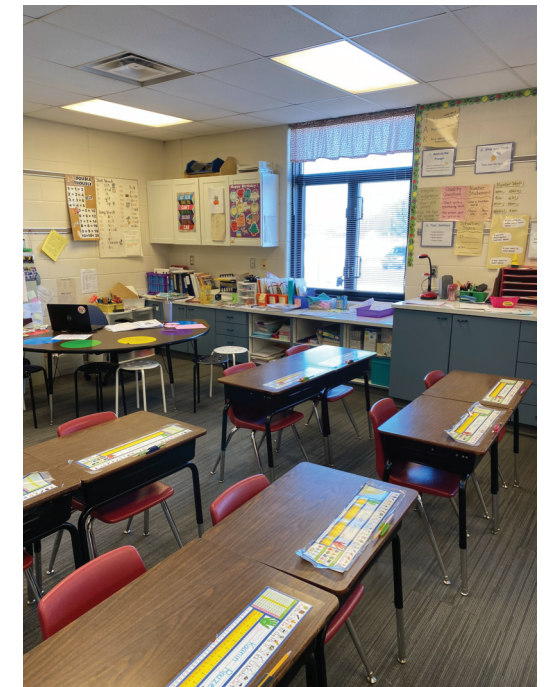
Typical classroom condition

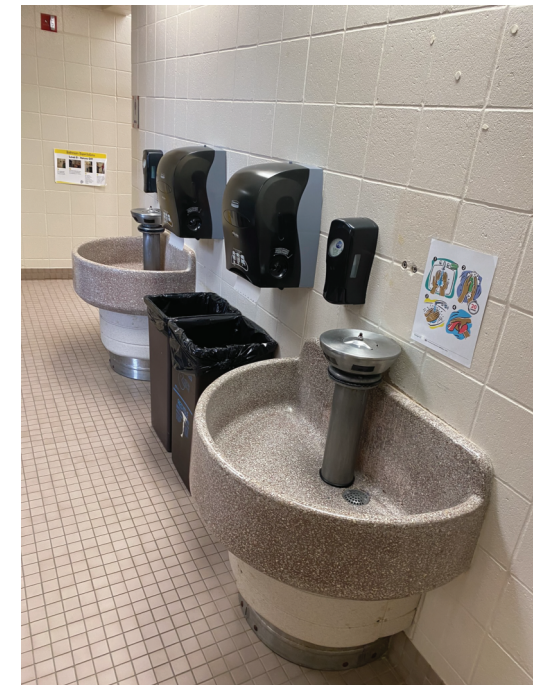
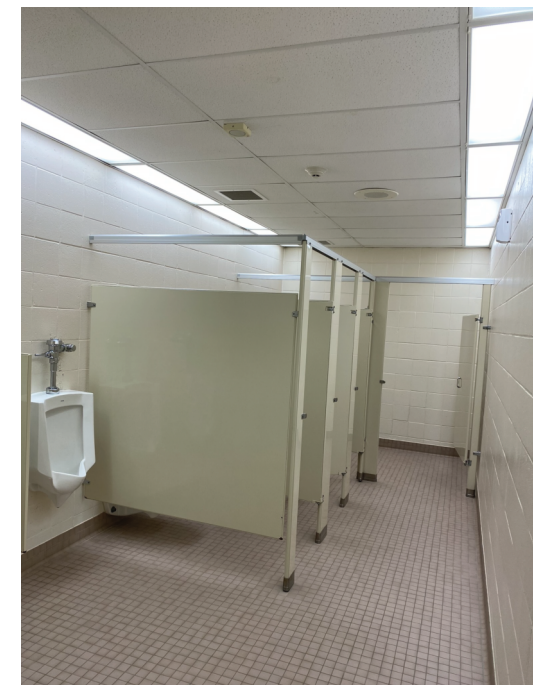
Partitions are metal, and appear outdated but are holding up and look ok. Flooring is holding up with the exception of some cracking of tile at one restroom. Ceiling tile does not appear to be moisture resistant/cleanable tile.

Typical bathroom condition

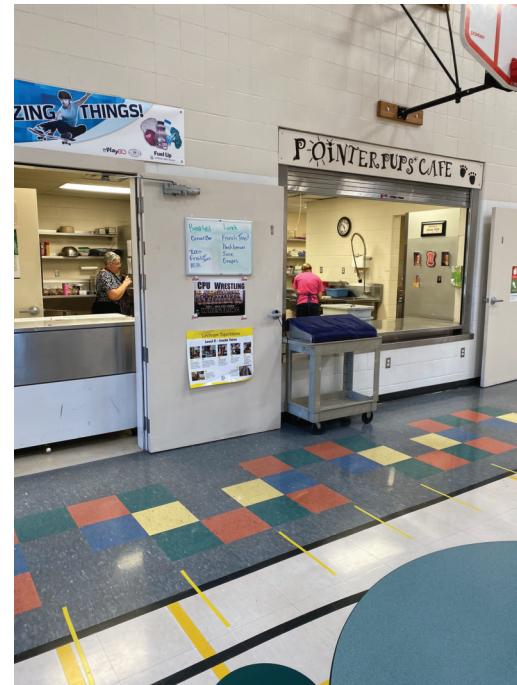
Area and equipment appears to be in good condition.

Kitchen/Serving condition

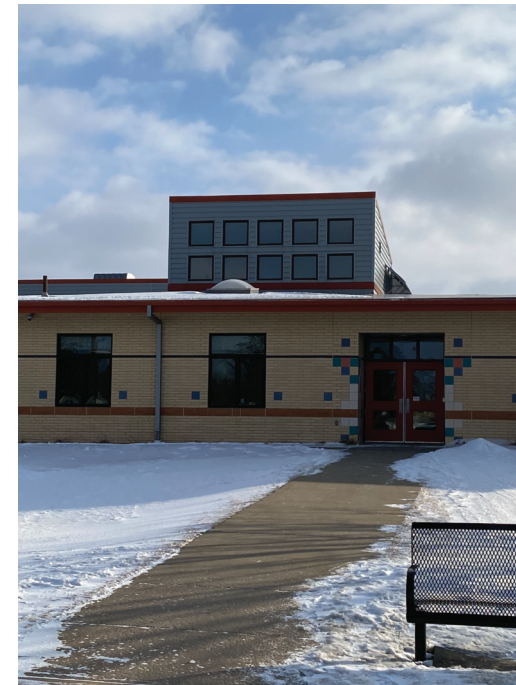
In good condition.

Typical exterior condition

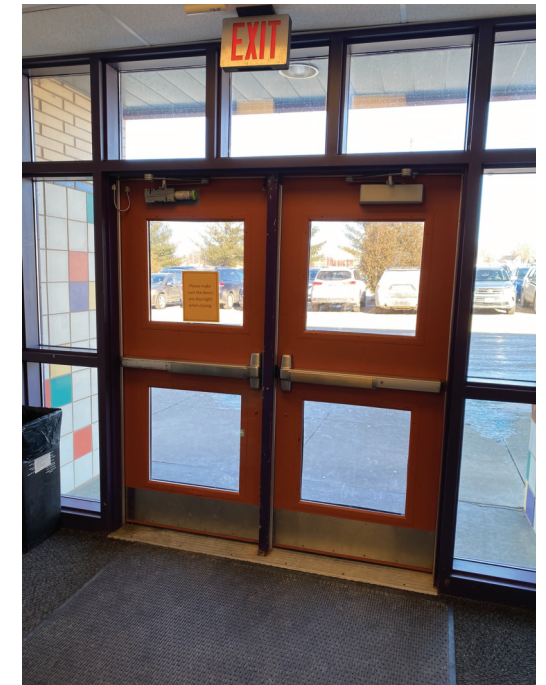
Exterior windows have been replaced with newer aluminum windows and are in good condition. Exterior entrance doors are still HM Doors and Frames and are starting to show rust & corrosion at ground level.

Typical entry condition

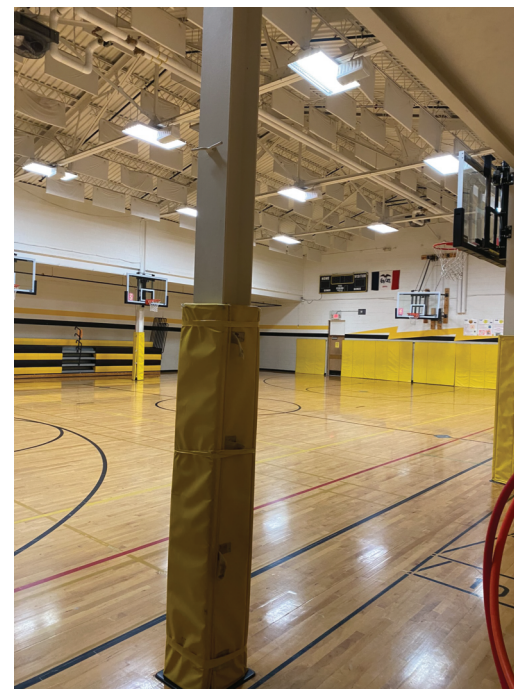
- Majority of the building is in fair condition
- Portions of the building to the South are new and in good condition
- A few spaces have not be recently renovated and in poor condition including the gym, a corridor, and set of bathrooms

Gym condition

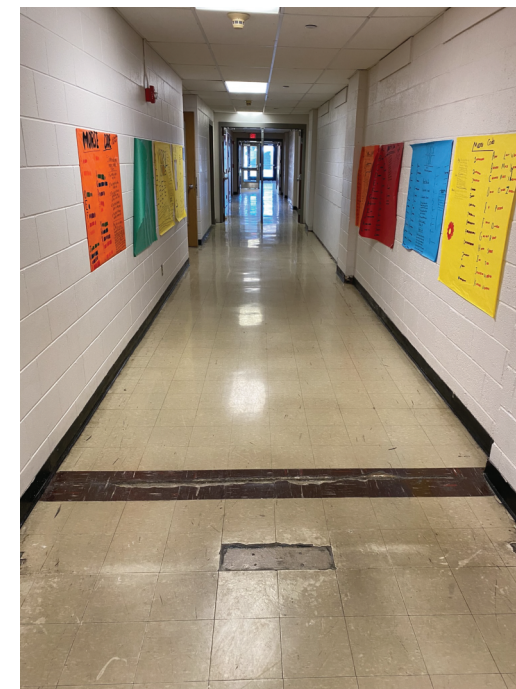
Poor condition corridor

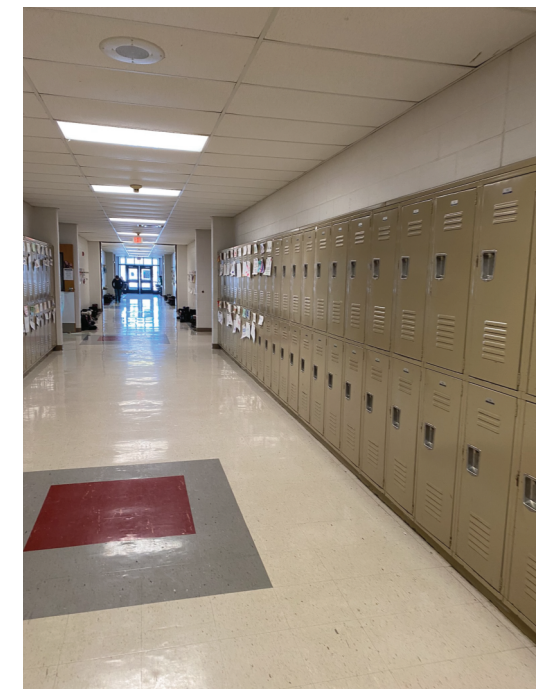
Typical corridor condition

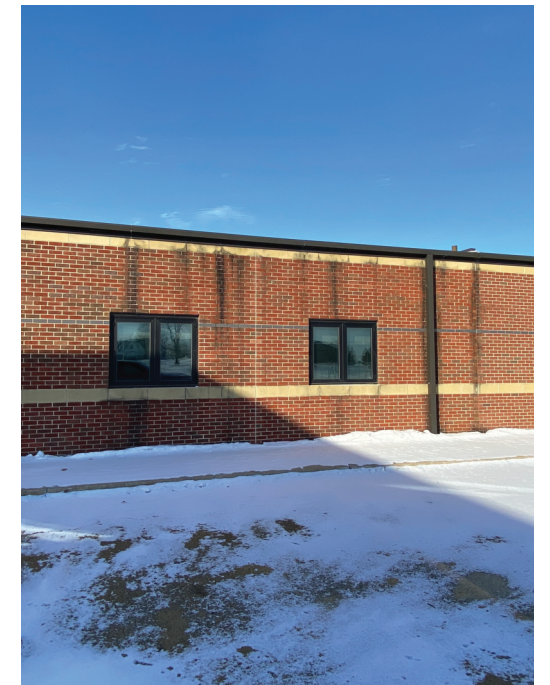
Staining at exterior masonry.

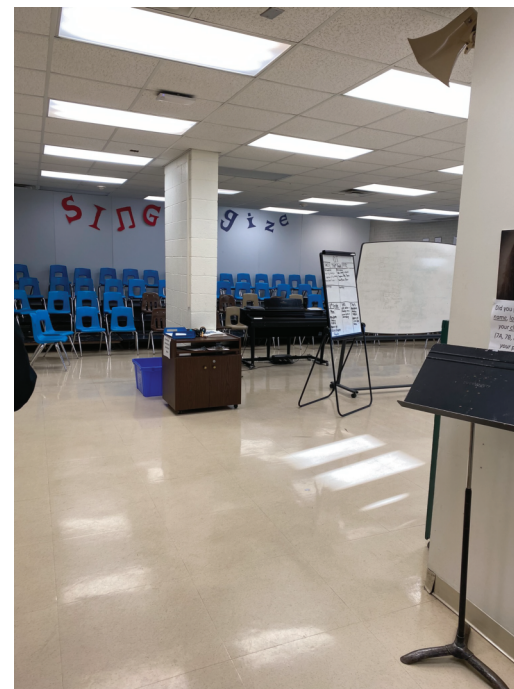
- A few portions of the building are in good condition including the commons area
- Several areas are in poor condition including the locker rooms, choir and band rooms, library, and kitchen
- The majority of spaces are in moderate condition but require new finishes

Vocal Music Condition

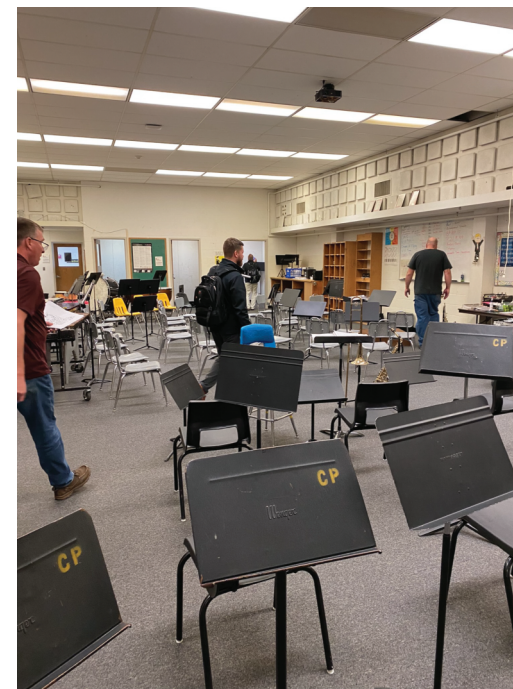
Instrumental Music Condition

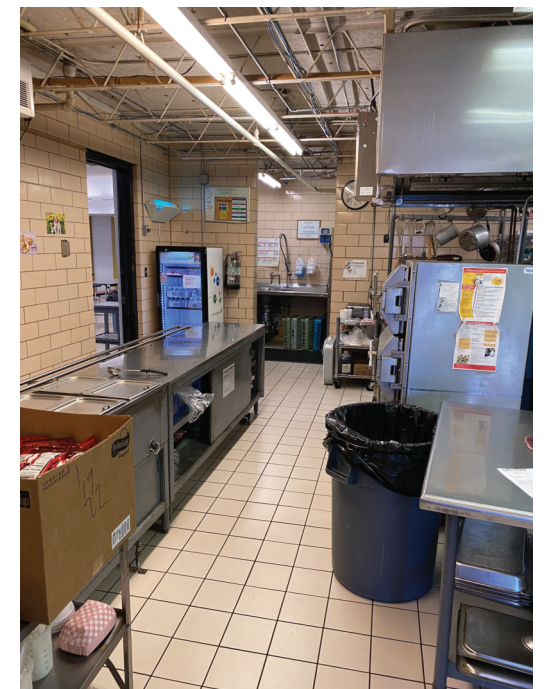
Food Service Condition

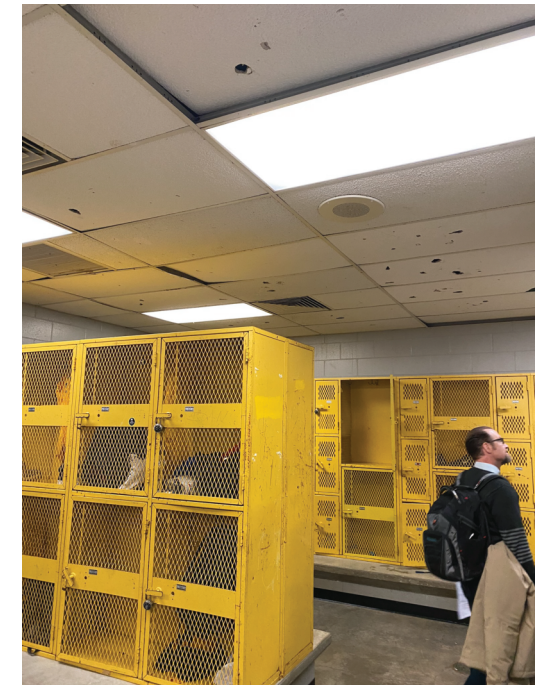
Some casework looks to be falling apart, it appears to be built in original to the addition. Athletic lockers are beat up and starting to rust. Would suggest new (more durable) casework.

Locker Room Condition

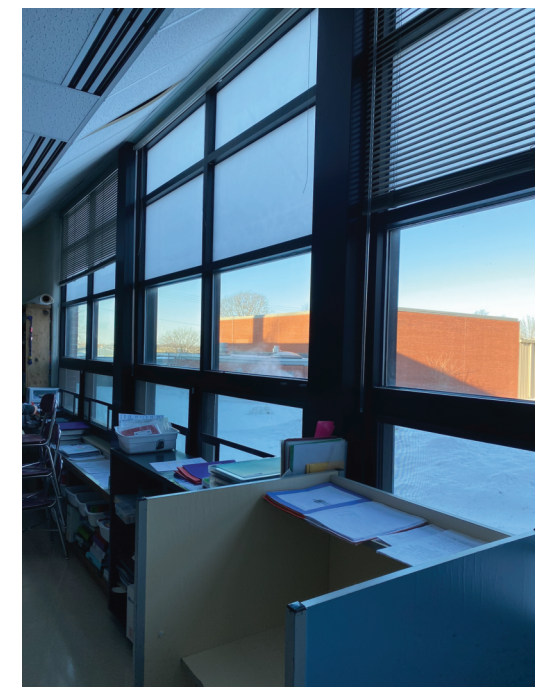
Exterior windows & doors have been replaced with newer aluminum windows and are in good condition.

Typical Exterior Window

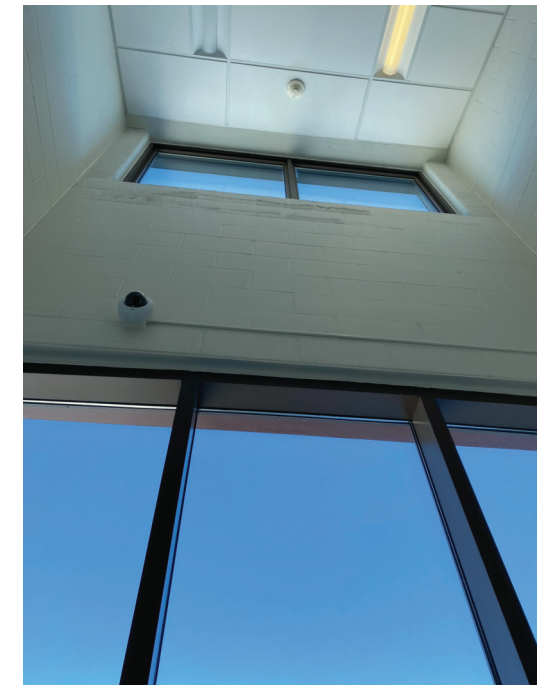
Cladding is failing and needs to be replaced.

Interior moisture issues from failing cladding

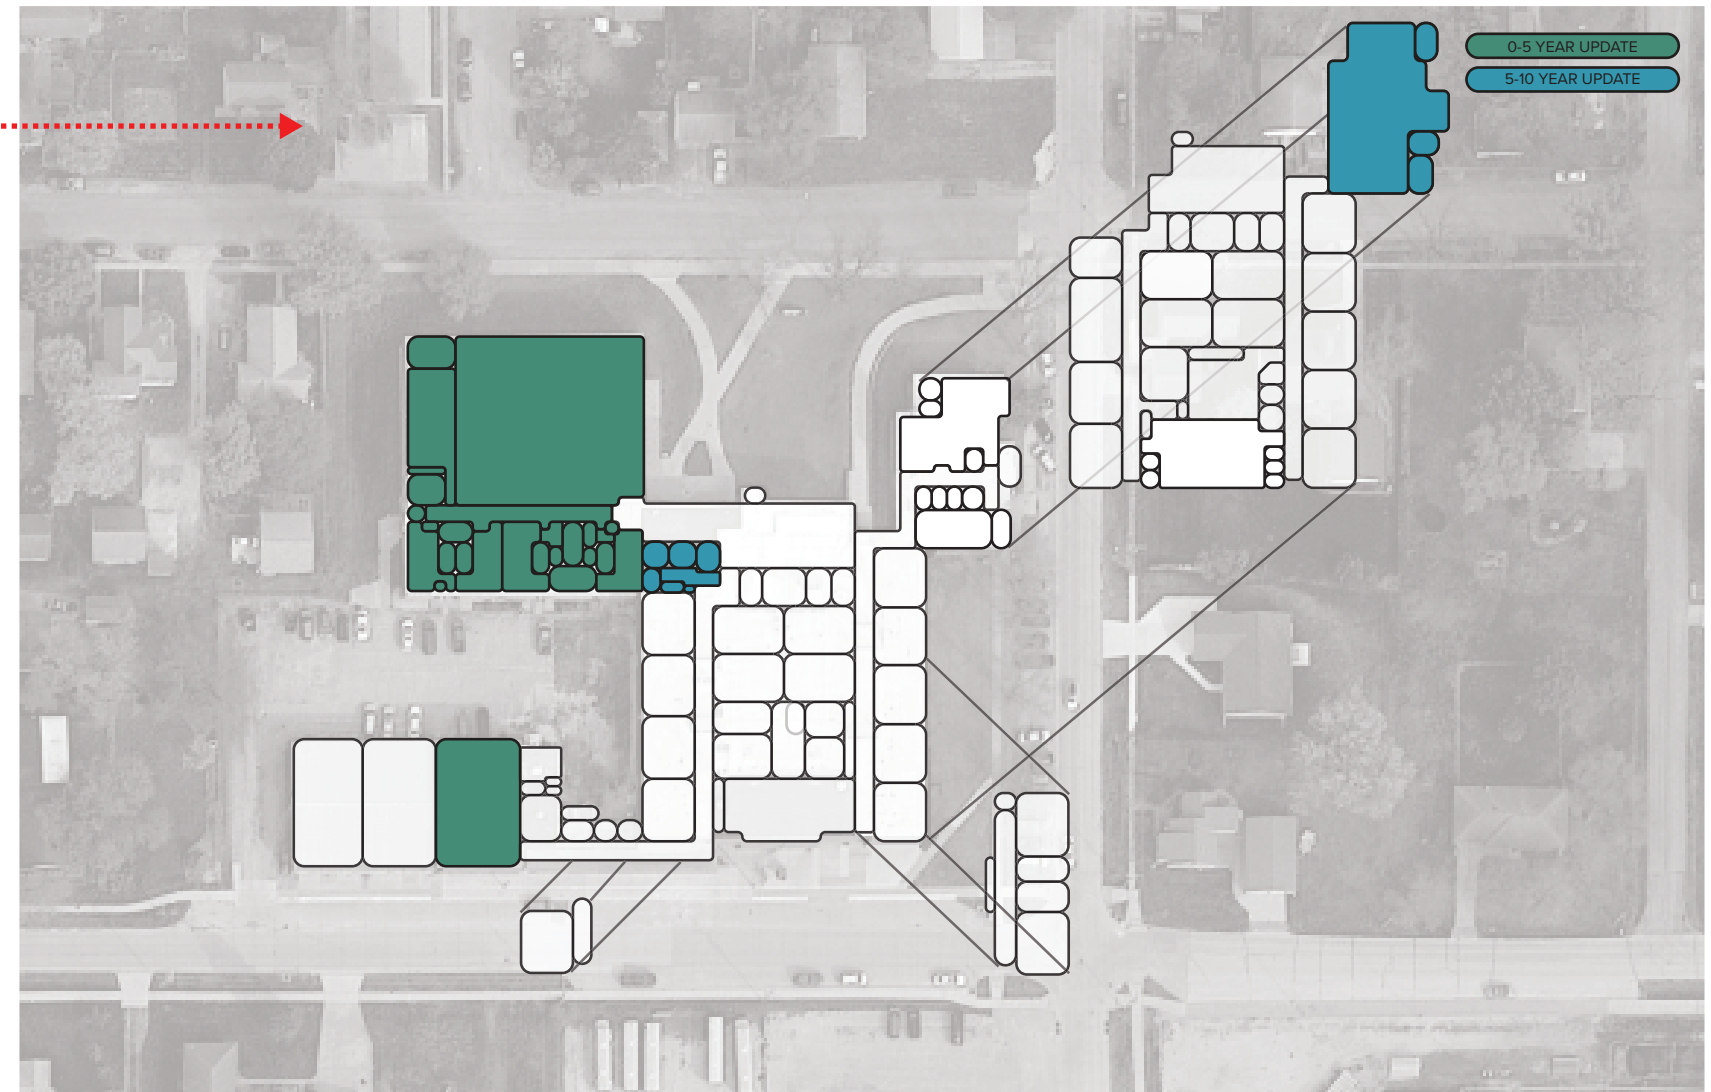
Areas requiring HVAC updates

- Replace HVAC system at locations indicated in diagram and per MODUS Engineering report (refer to appendix A)
- Partial roof replacement (75%)
- Tuckpoint masonry and repair flashing as needed
- Provide fire suppression system and new ceilings for 80% of building
- Provide new LED light fixtures per MODUS Engineering report (refer to appendix A)
- Provide finish upgrades for entire building including ceilings, flooring, doors, and paint
