**CENTER POINT-URBANA COMMUNITY SCHOOL DISTRICT
FACILITIES MASTER PLAN
2022**

CENTER POINT-URBANA CSD MASTER PLAN

EXECUTIVE SUMMARY

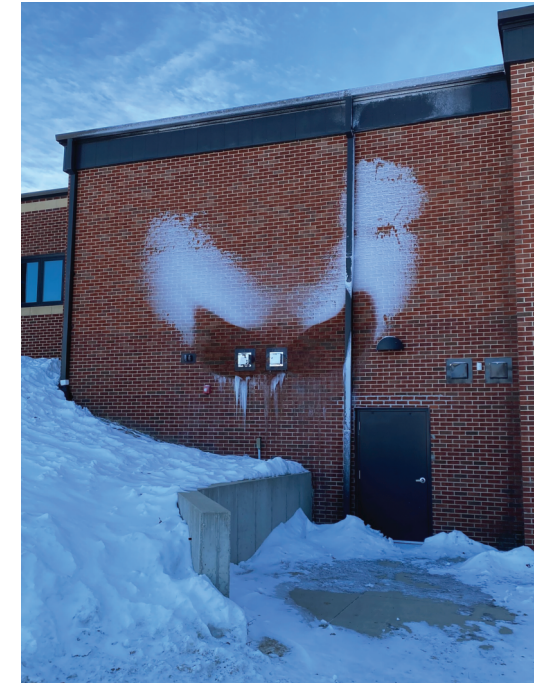
Exhaust condensation at exterior masonry.
