**CENTER POINT-URBANA COMMUNITY SCHOOL DISTRICT
FACILITIES MASTER PLAN
2022**

CENTER POINT-URBANA CSD MASTER PLAN

EXECUTIVE SUMMARY

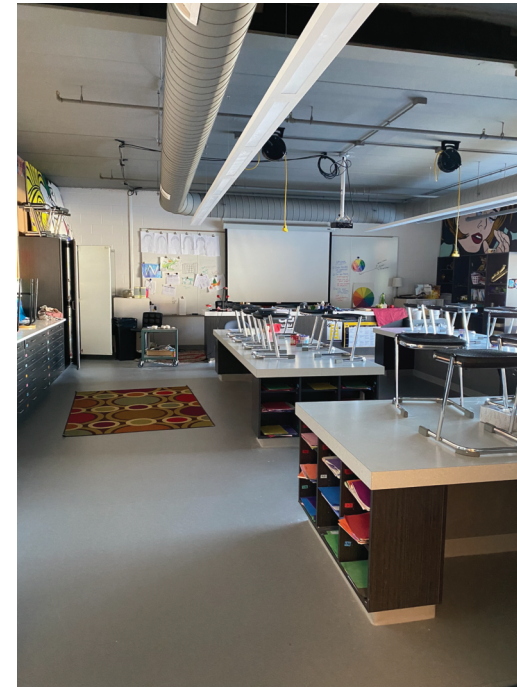
Typical Addition Classroom Condition

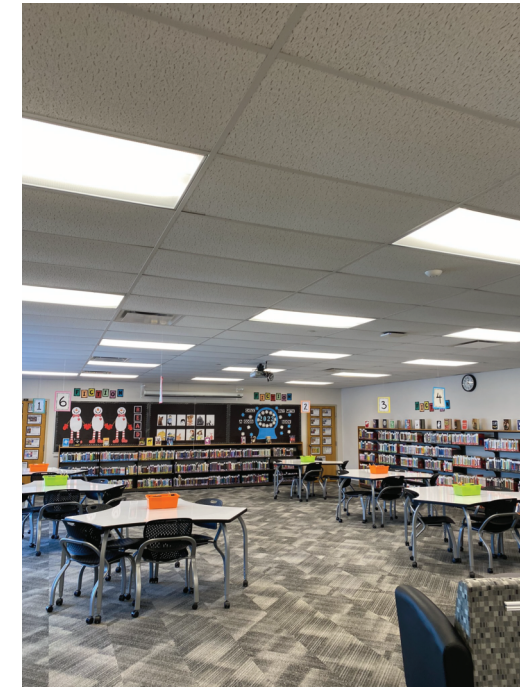
Media Center

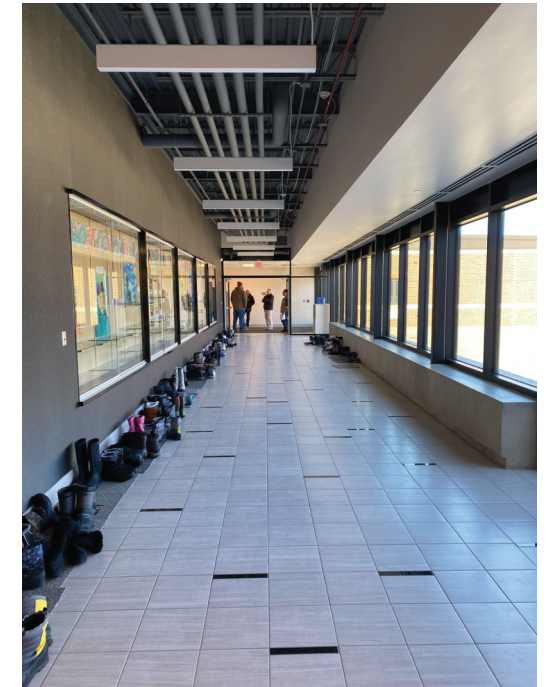
Addition Corridor

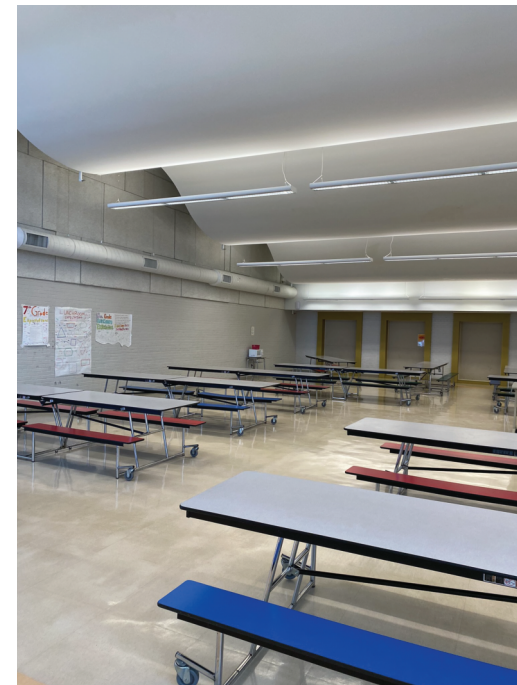
Cafeteria Condition

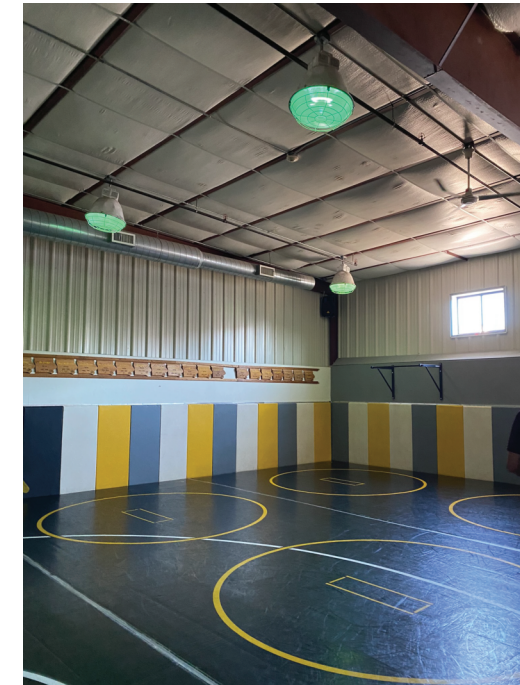
Wrestling Room

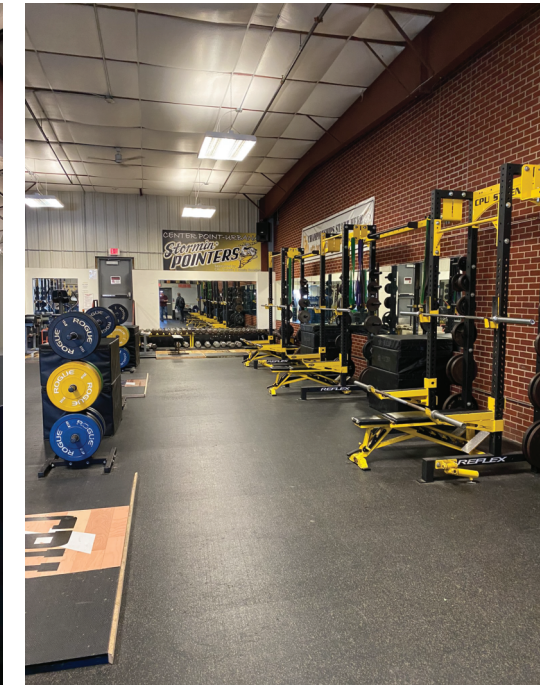
Strength and Conditioning

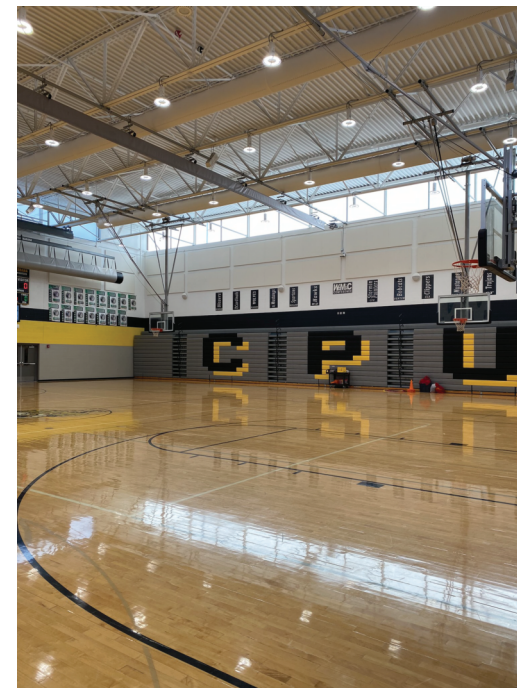
Gym Condition

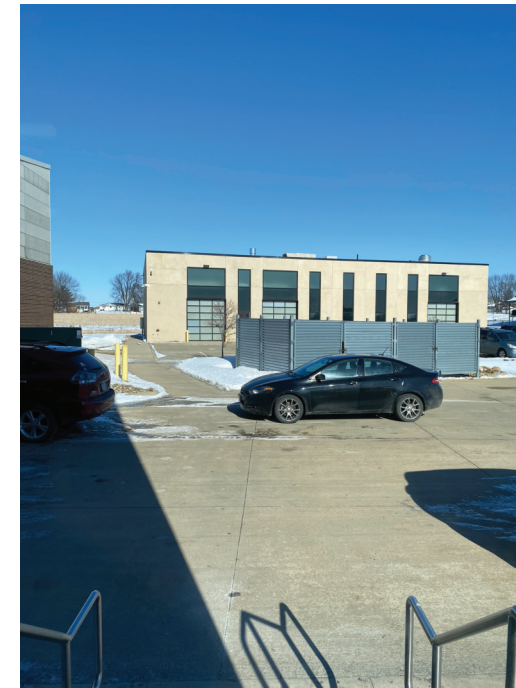
Industrial Tech Building

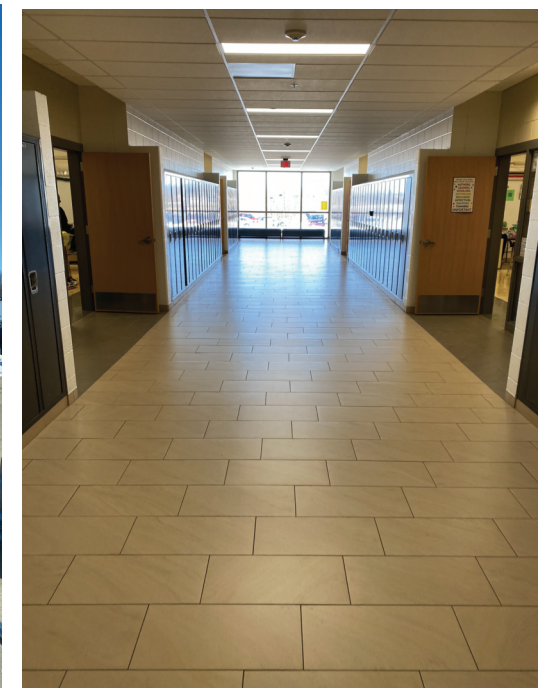
Typical Corridor

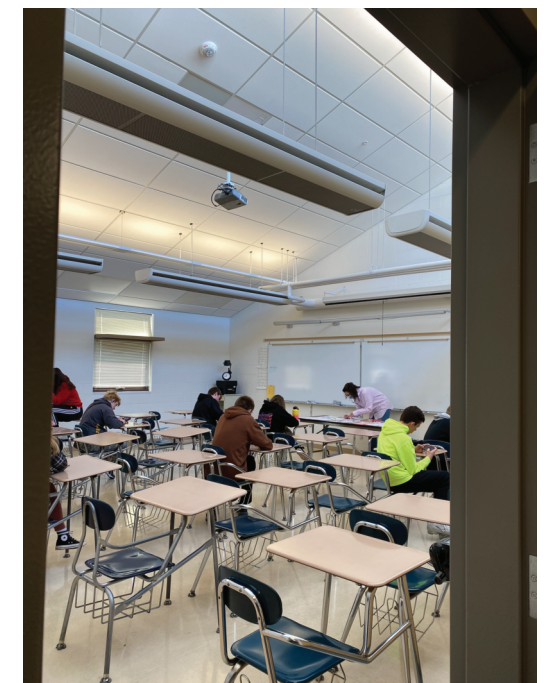
Typical Classroom
